NPCA WATER QUALITY MONITORING PROGRAM:

2009 ANNUAL REPORT

APRIL 2010

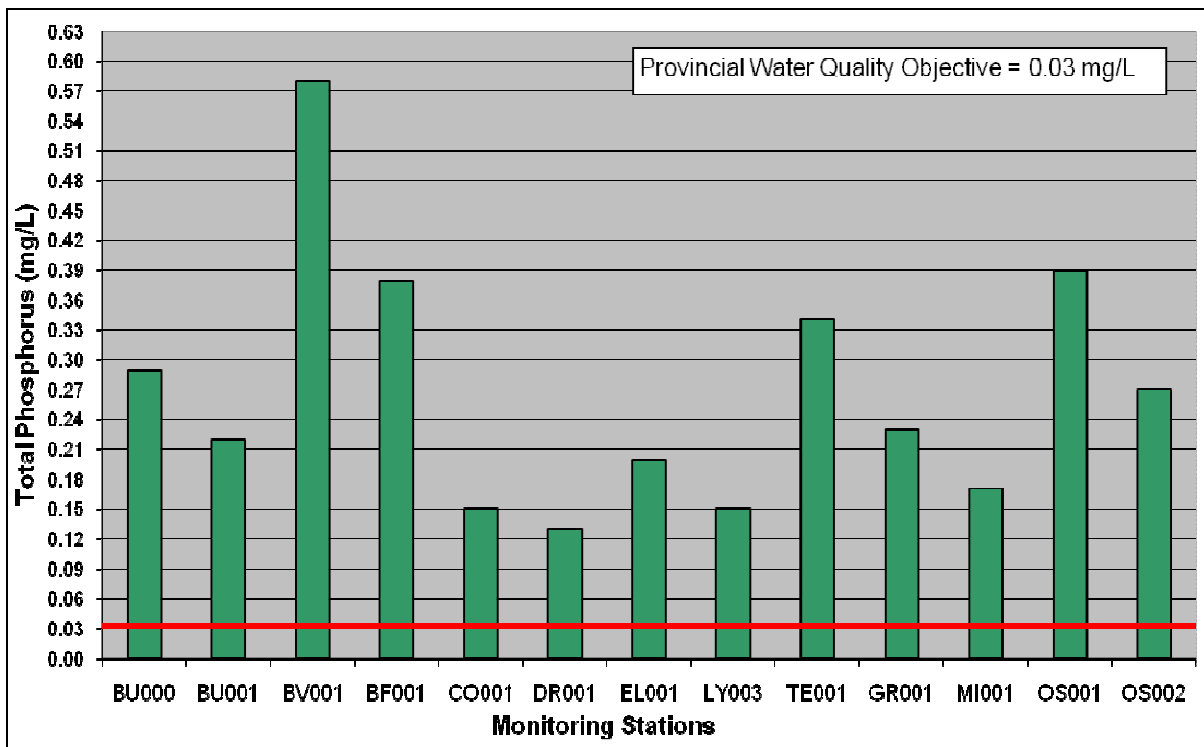
Figure 3: Mean total phosphorus concentrations in Welland River tributaries 2002-2009

- Similar to the Welland River, water quality in all tributaries monitored is impacted by elevated concentrations of total phosphorus. High concentrations of phosphorus are a widespread cause of water quality impairment in these tributaries. 100% exceedance is observed at most stations with total phosphorus concentrations up to three orders of magnitude higher than the provincial objective. As shown in **Figure 3**, mean total phosphorus concentrations at all stations greatly exceed the provincial objective, particularly at stations BV001, BF001 and OS001. Of the 68 NPCA surface water quality monitoring stations, Beaver Creek station BV001 again has the highest mean concentration of total phosphorus in 2009. Manure from livestock operations, sewage discharges, soil erosion, fertilizers, and pesticides are likely sources of total phosphorus in these tributaries.

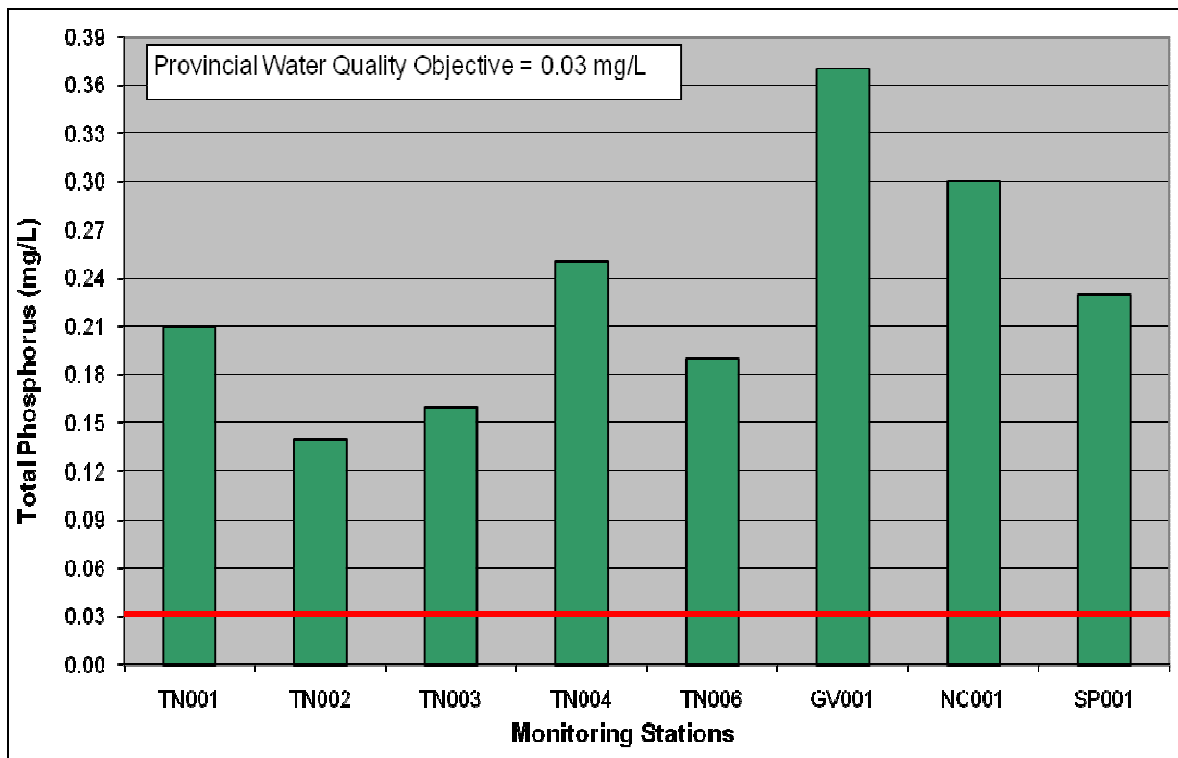
Figure 5: Mean total phosphorus concentrations in the Twenty Mile Creek watershed 2002-2009

- Water quality at all monitoring stations is impacted by elevated concentrations of total phosphorus. Total phosphorus is a widespread cause of water quality impairment in the Twenty Mile Creek watershed, and frequent exceedances of the provincial objective occur at all stations. As shown in **Figure 5**, mean total phosphorus concentrations for the Twenty Mile Creek watershed greatly exceed the provincial objective at all stations, particularly stations TN004, GV001 and NC001. Manure from livestock operations, sewage discharges, soil erosion, fertilizers, and pesticides are likely sources of total phosphorus in this watershed.

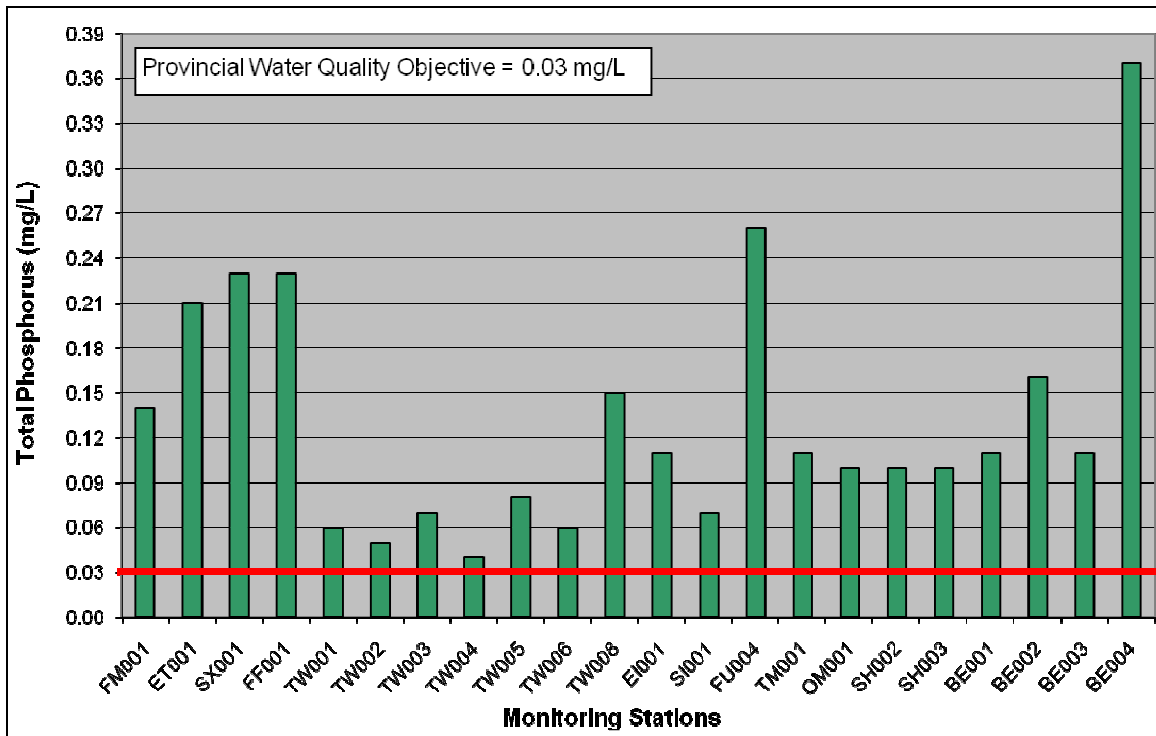
Figure 7: Mean total phosphorus concentrations in Lake Ontario tributaries 2003-2009

- Eighteen, Sixteen, and Fifteen Mile Creeks are primarily agricultural watersheds and are impacted by elevated concentrations of chloride and total phosphorus. As shown in **Figure 7**, phosphorus concentrations are especially elevated at Fifteen Mile Creek station FF001 and Sixteen Mile Creek station SX001. Erosion

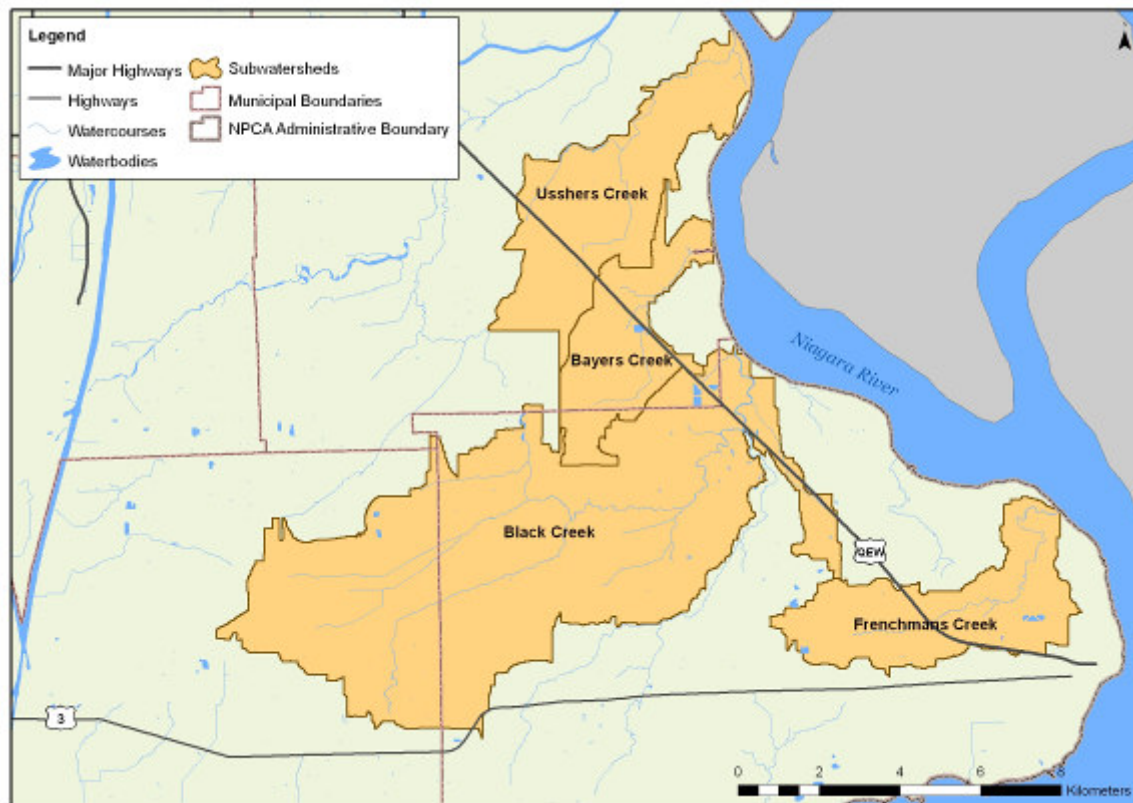
Figure 8: Map of the subwatersheds monitored for water quality in the Niagara River watershed outside of the Welland River

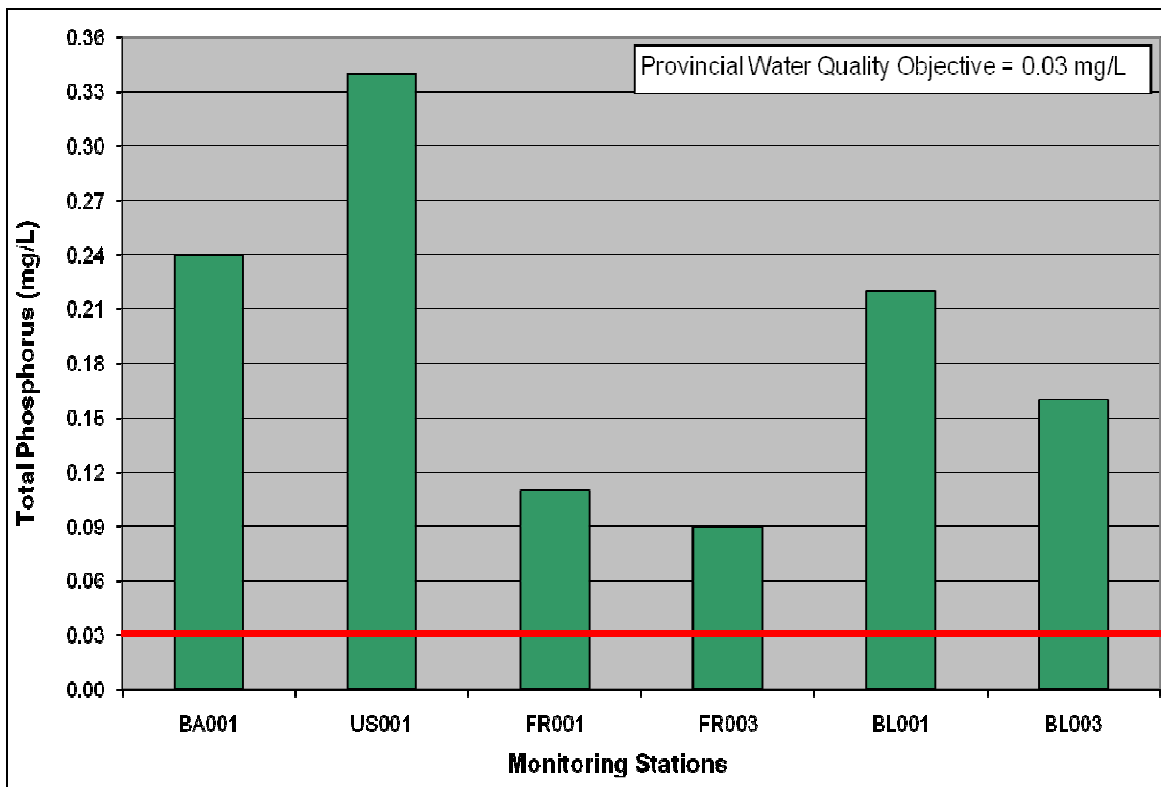
Figure 9: Mean total phosphorus concentrations in Niagara River tributaries 2003-2009

- Water quality is negatively impacted by high concentrations of total phosphorus with 100% exceedance observed at all stations. As shown in **Figure 9**, mean total phosphorus concentrations exceed the provincial objective at all stations, particularly at Usshers Creek station US001. Sources of phosphorus at these stations include runoff from urban and agricultural landuse, sewage discharges, and soil erosion.

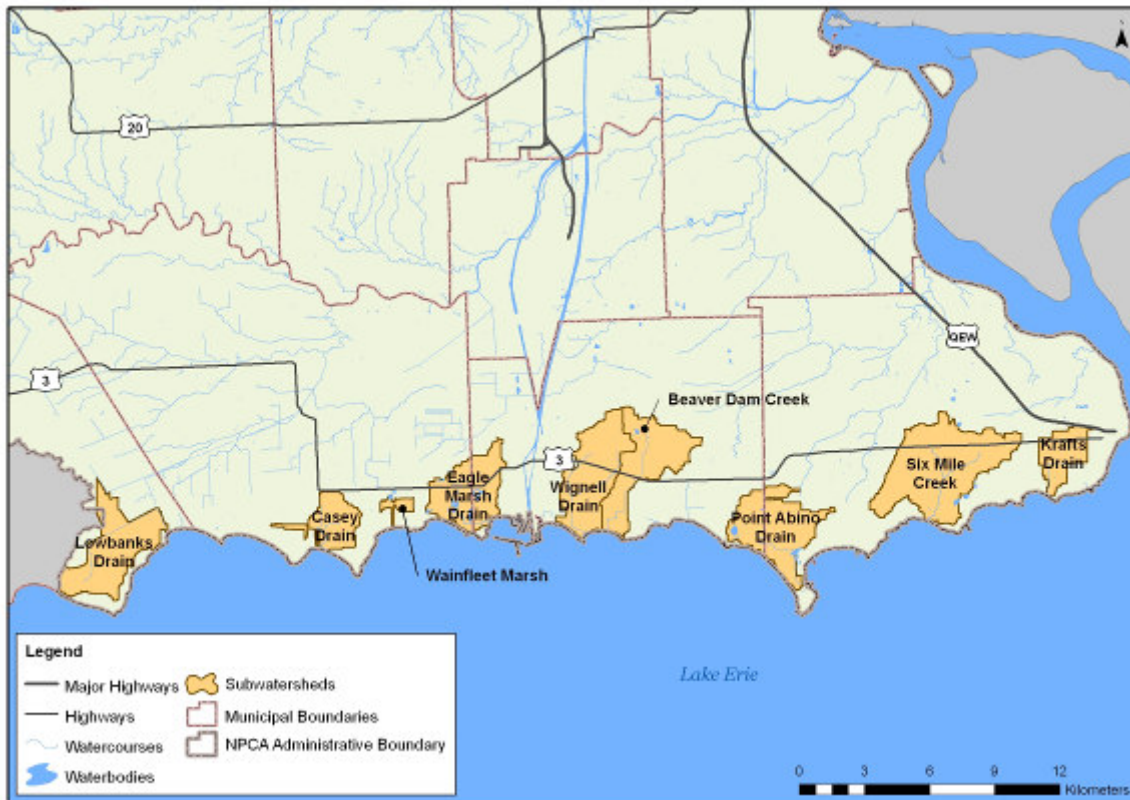
Figure 10: Map of the subwatersheds monitored for water quality along the north shore of Lake Erie
